St. Joseph's Church Inspection
Mescalero, NM

Submitted to: Las Cruces Catholic Diocese
Submitted by: NMSU ASCE Student Chapter

Inspection performed: February 26, 1994
Report Submitted: March 19, 1994

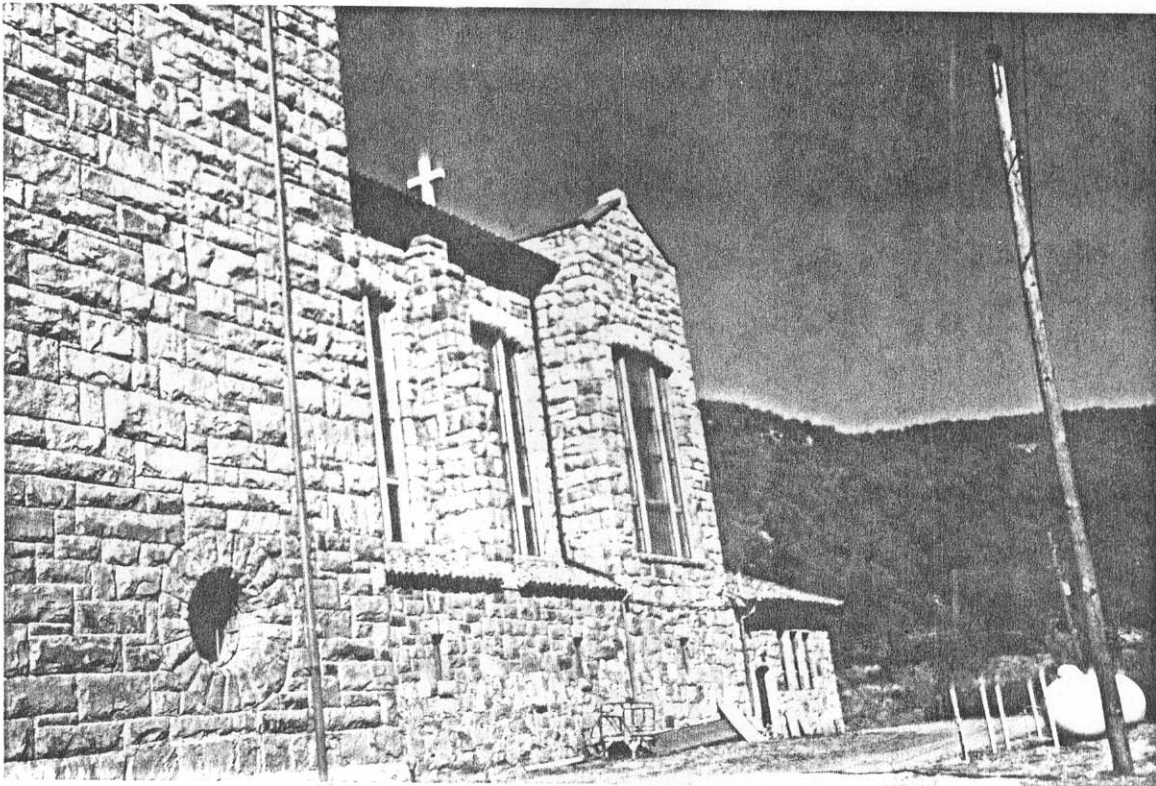
Photographs 1 through 4 below show partial views of the south wall and the east end extension of the church. Elevation data for the eave of the low roof was collected by team 1 to determine the elevation differences along the eave line. There are three low roof sections along the south wall. At the east end, the low roof eave is continuous around the three unattached sides of the extension. The bottom surface of the eave rafter at the outside wall of the building was the reference elevation point. These rafters are visible in photo 4.

Figure 4: View of low roofs of south wall and south side of east end extension.

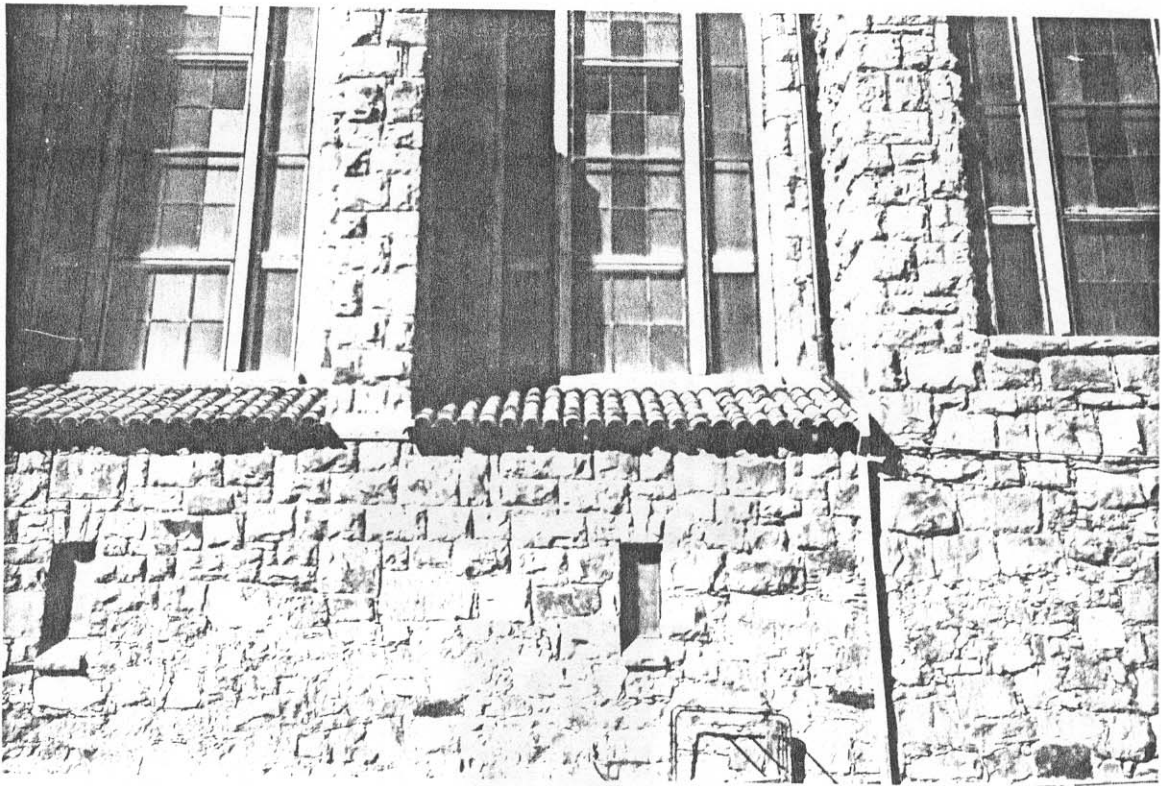
Figure 5: View of the center and east sections of the low roof along the south wall

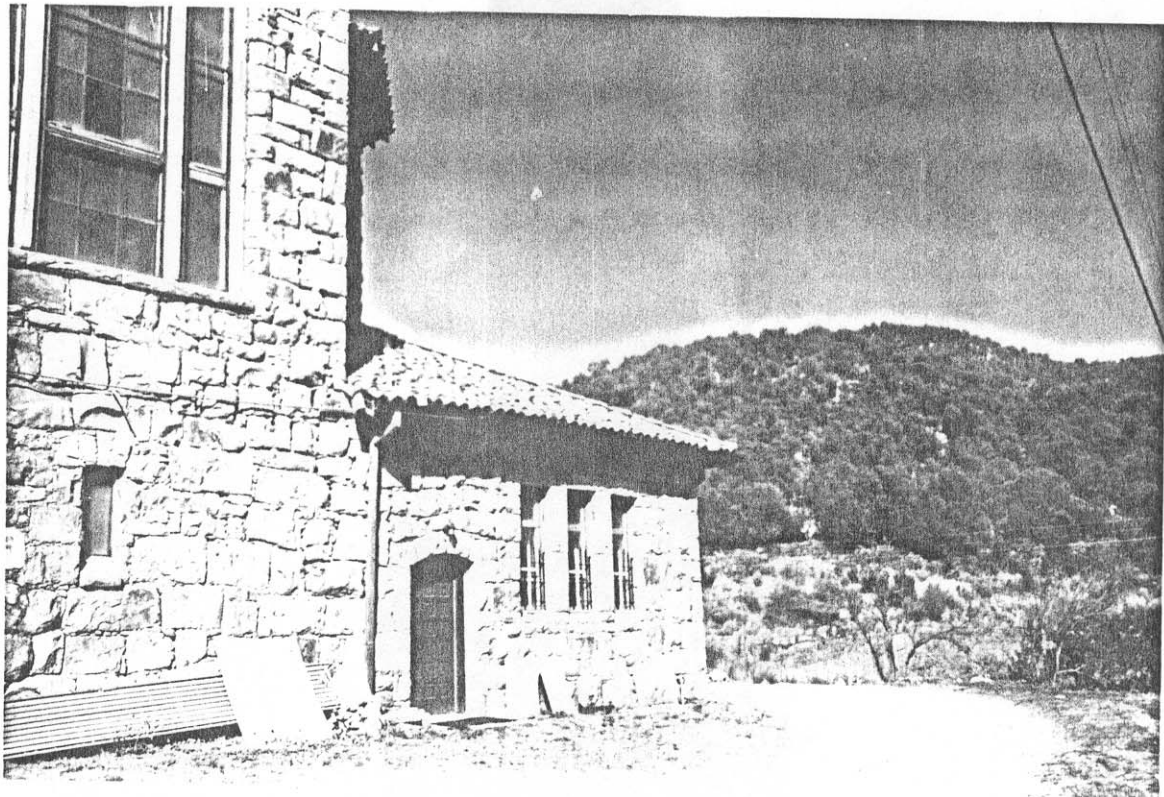
Figure 6: View of the east end extension from the south

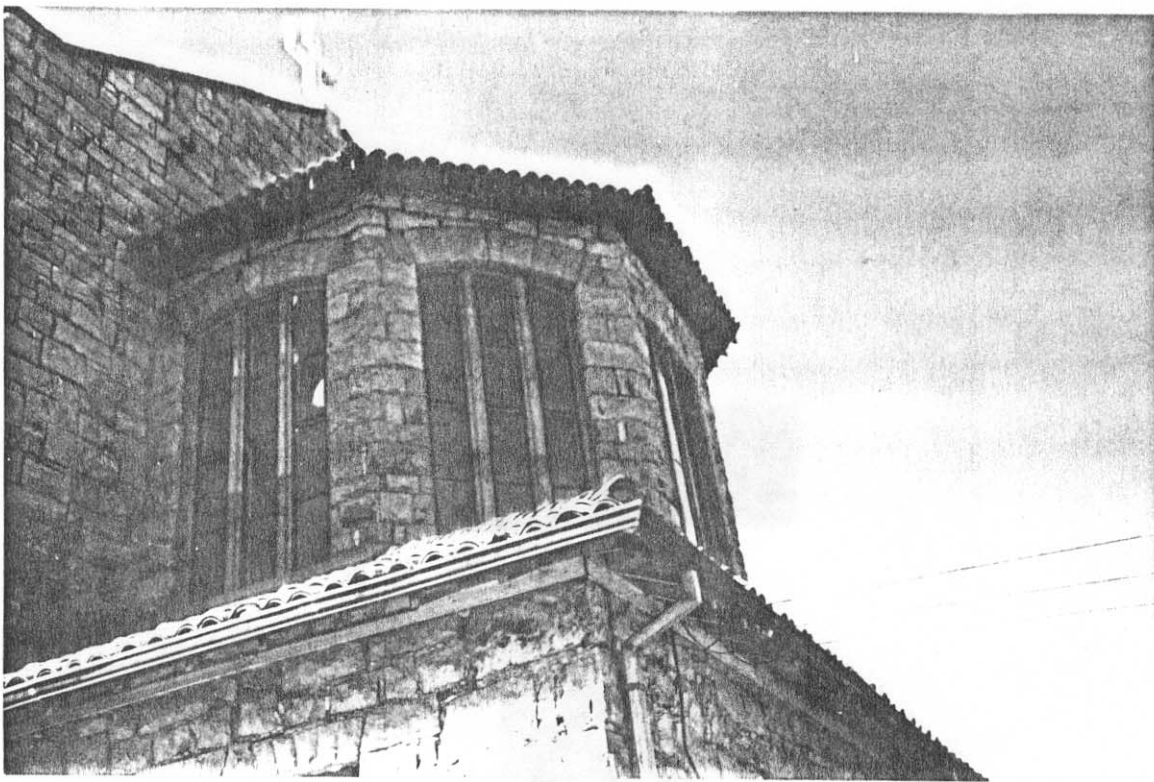
Figure 7: View of the southeast corner of the east end extension
 (Note the eave rafters from which rod readings were made)

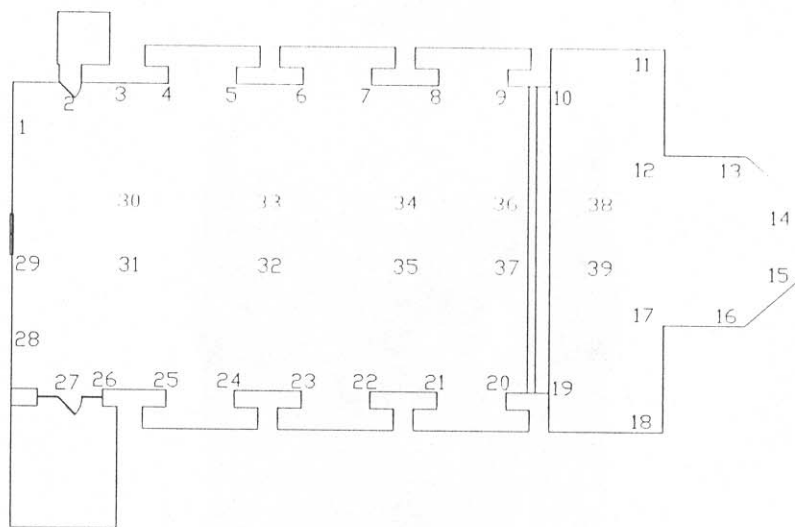
Figure 9: Inside survey data points

Because the elevations are so close, it can be concluded that no settling has occurred in the church.

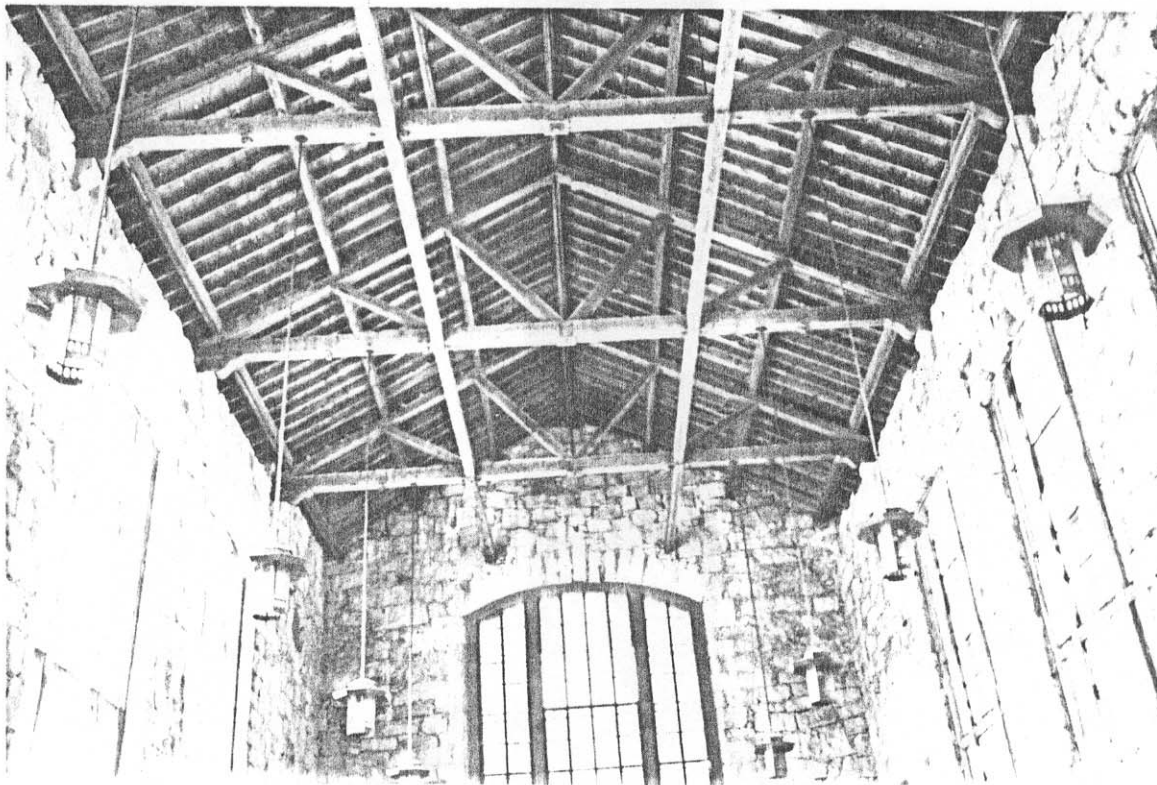
The interior roof support system, as observed from the floor of the church, appears to be in good condition. The system consists of timber trusses which span the width of the church and are supported by stone buttresses. Timber beams, which run parallel to the church side walls, connect the trusses. The following photo illustrates the interior roof support system.

Figure 10: Interior roof support system

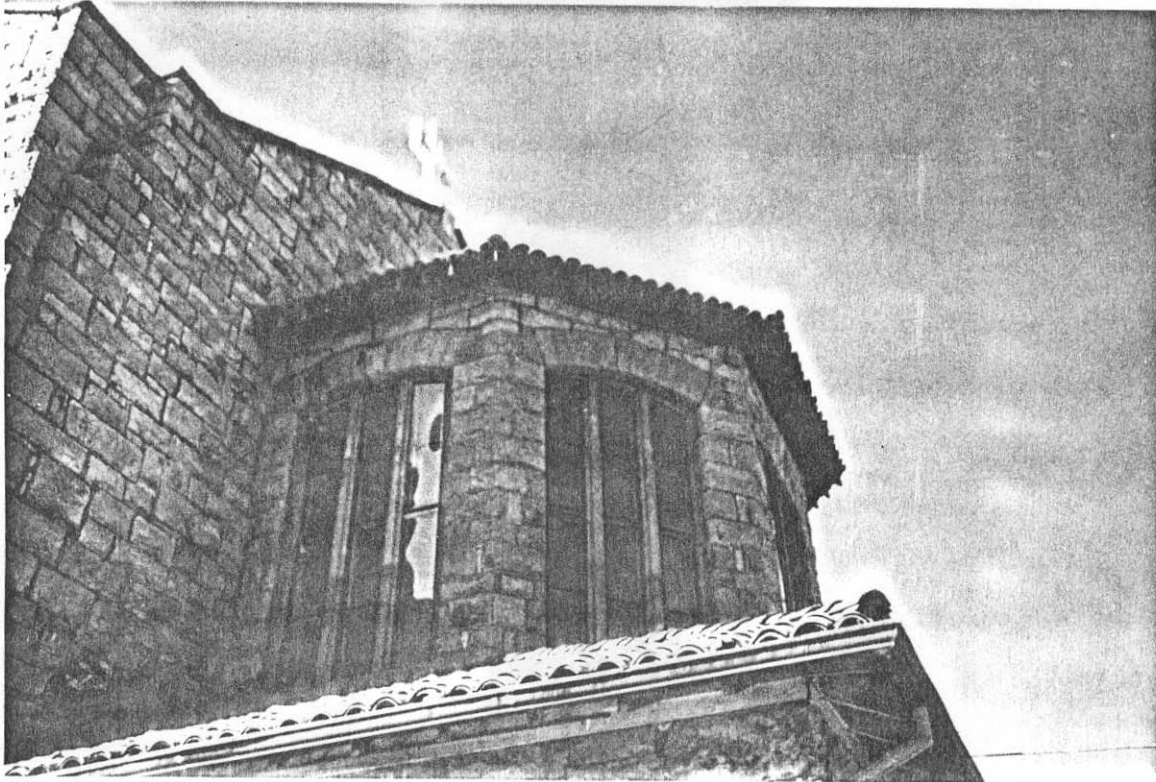
The major problem that was observed concerning the exterior roof was the lack of a sufficient roof drainage system. During precipitation, some water fails to drain off of the roof. This is especially damaging under freezing conditions because of the expansion that takes place when water freezes. The water that does drain from the roof is not sufficiently carried away from the building. As a result of this, leaching of the exterior walls has occurred as shown in the photo below.

Figure 11: Leaching of the exterior walls

The addition of a gutter system to provide positive drainage away from the structure would decrease the water damage on the building. Refer to photo set six for other photos that display the roof drainage problem.

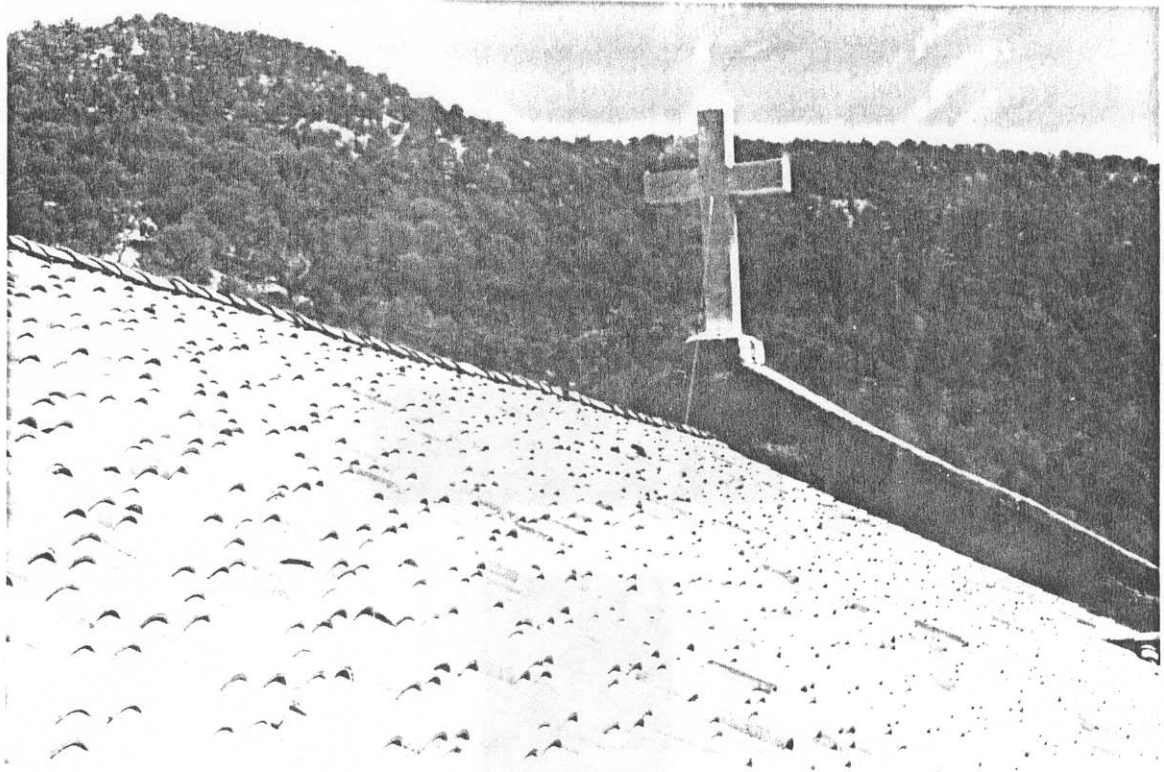
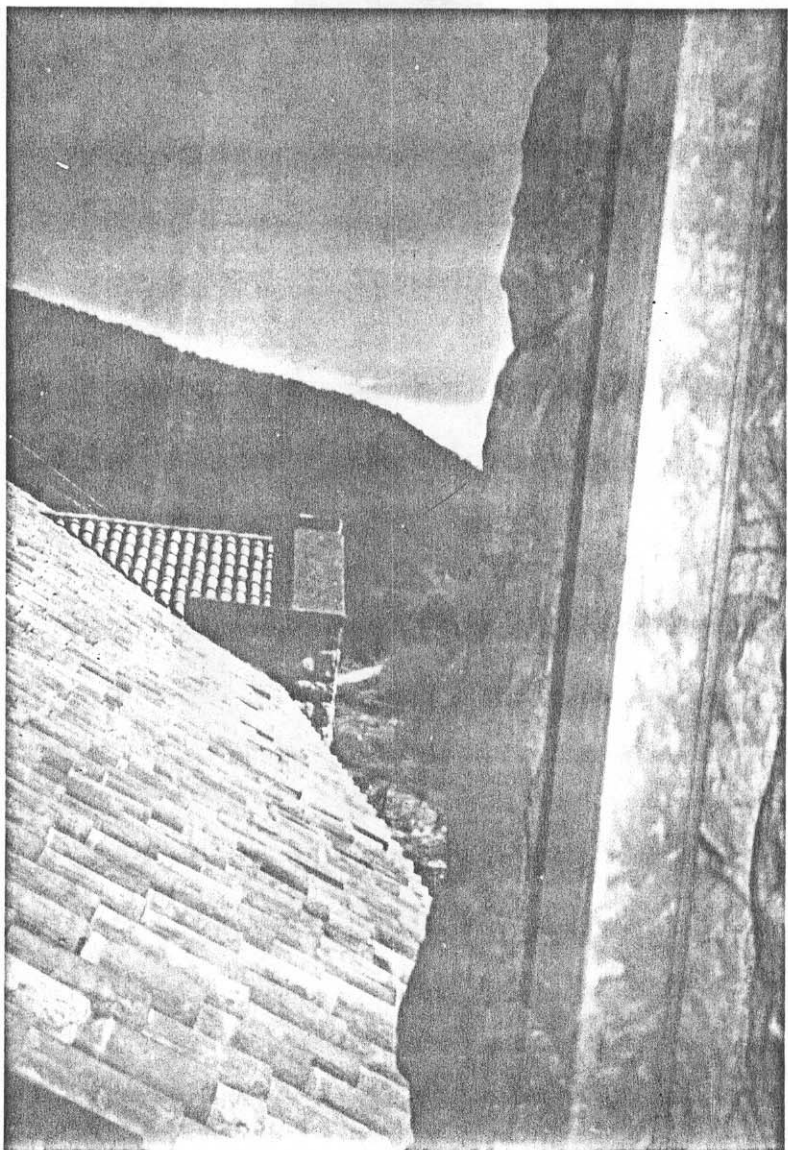
Photo Set 2 - Exterior Roof

The exterior roof is supported by timber decking which rests on the interior truss support system. The roofing tiles are fragile and many of them are broken; consequently, leakage occurs during rainfall. Photo set two (in appendix) includes several pictures of the roofing tiles.
