TECHNICAL SITE VISIT

ST. JOSEPH'S MISSION CHURCH  
MESCALERO , NEW MEXICO

DALE F. ZINN  
ARCHITECT

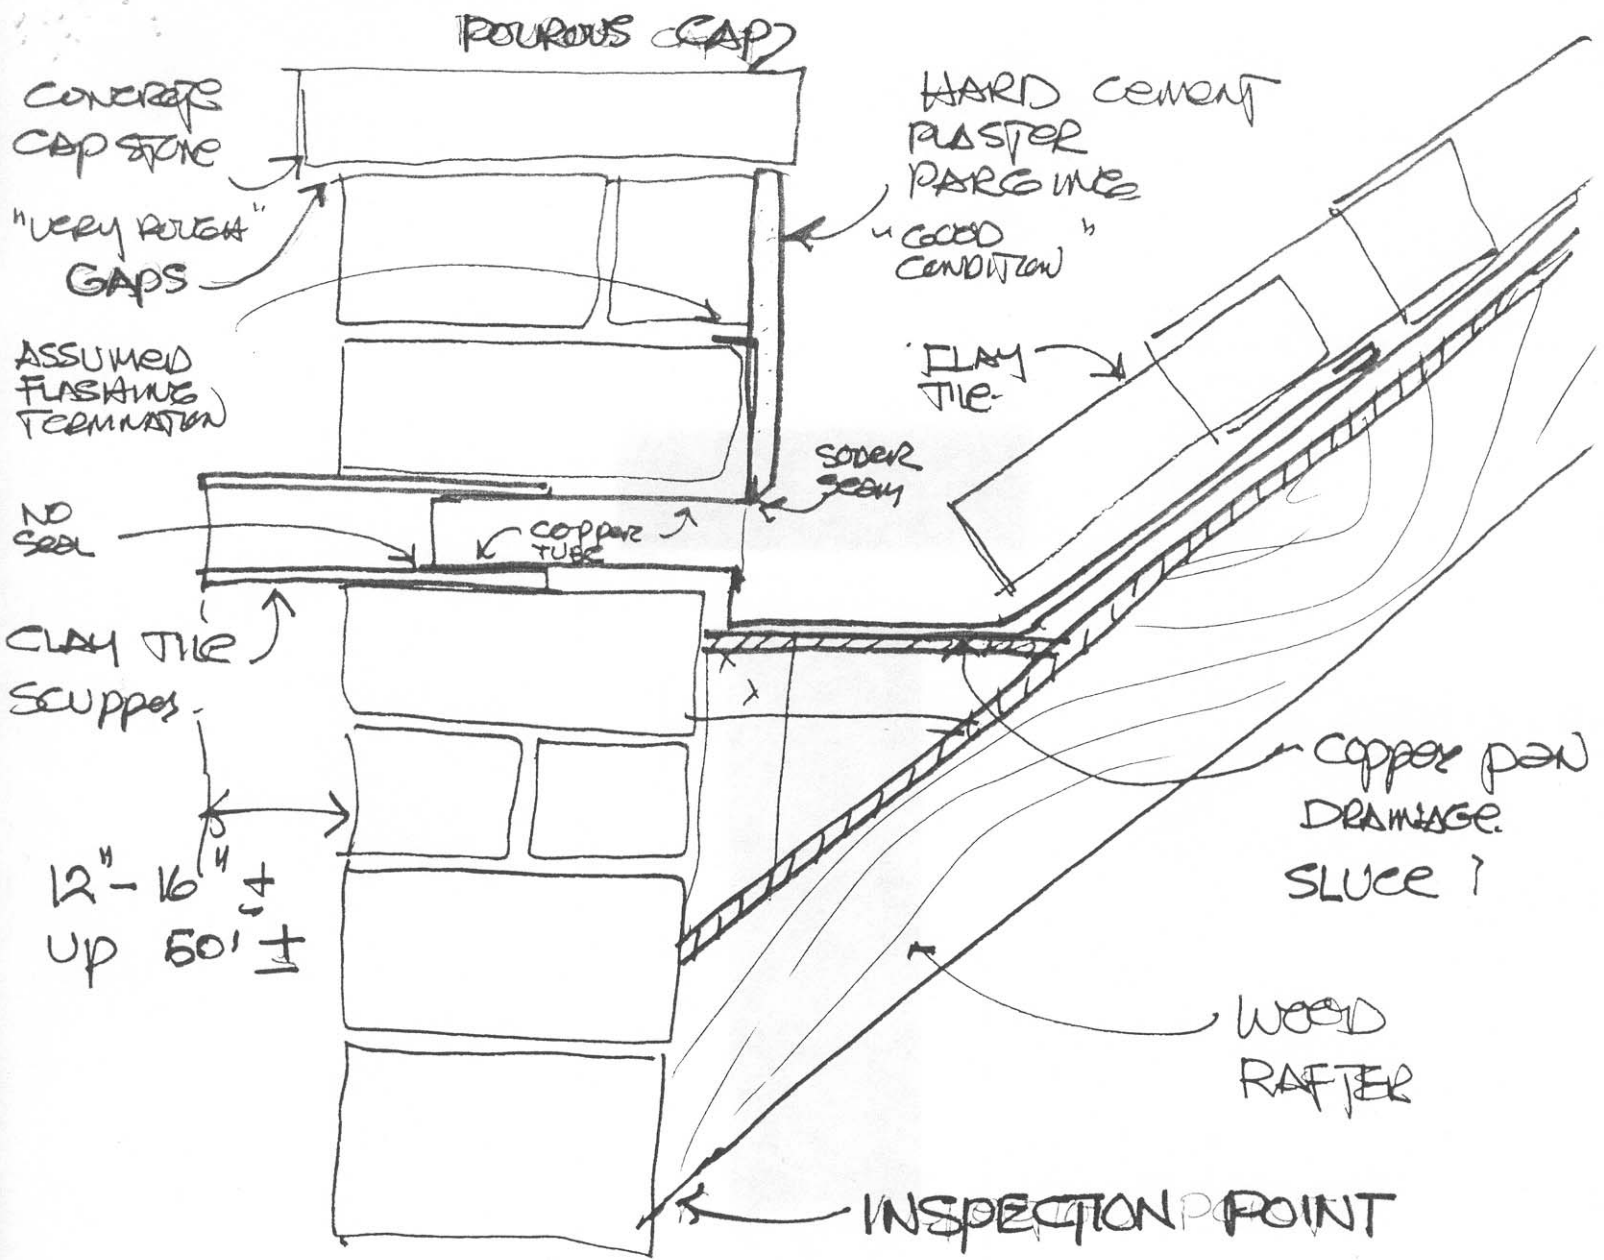
SECTION OF SCUPPER THRU WALL  
 @ SE/SW CORNER. - EXISTING CONDITION

Roof drainage patterns were altered slightly at some time in the past. Where the main roof and cross aisle gable roofs intersect there are areas that were intended originally to drain the lower portions of these roofs directly through the wall. ( see sketches ) The drainage has been altered to eliminate a drain pipe and the roof water is directed to a point around the parapet walls to another point where the water is allowed to run out through a copper or brass tube in the wall. The tube is integral to the metal flashing on the inside face of the parapet. The tubing was subsequently been cut off inside of the stone wall where it now passes through and is loosely fitted to a clay sewer pipe that extends out of the wall. Water generally exits the clay pipe and spills over the stone faces of the church and eventually to the ground.
