St. Joseph's Church Inspection
Mescalero, NM

Submitted to: Las Cruces Catholic Diocese
Submitted by: NMSU ASCE Student Chapter

Inspection performed: February 26, 1994
Report Submitted: March 19, 1994

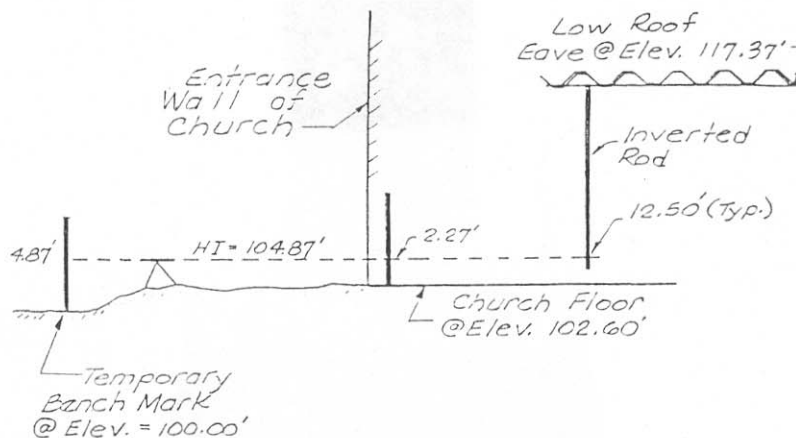
Figure 8: Typical level setup

An assumed elevation of 100.00 feet was assigned to a temporary benchmark to obtain a height of instrument(HI). The entrance floor of the church was determined to have an elevation of 102.60 feet. Readings were taken on an inverted rod set at the eave of the low roof at selected points around the south side and the east end extension of the building.

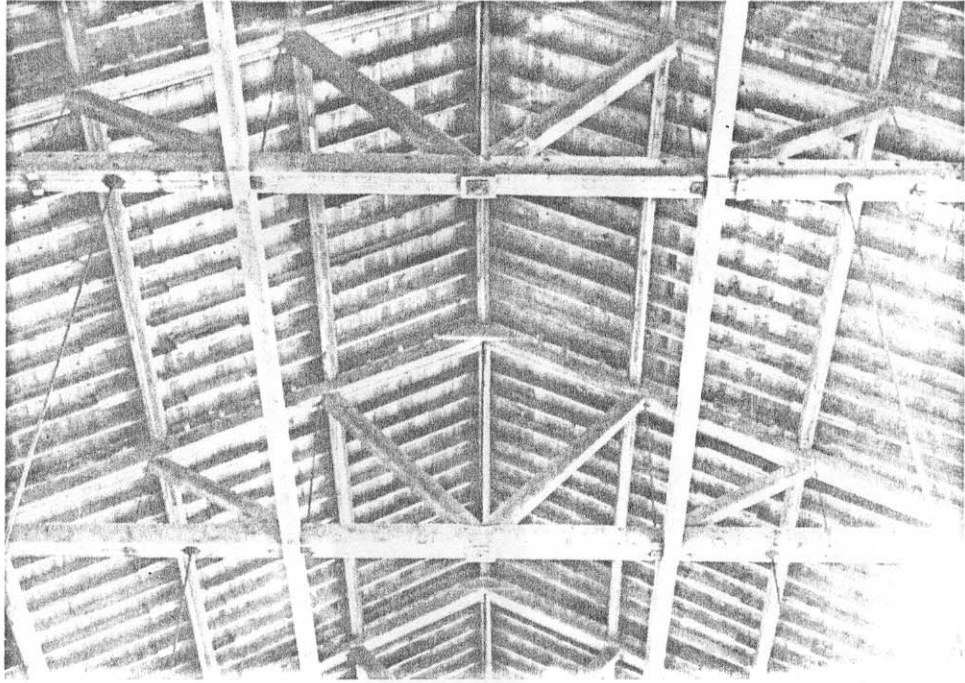
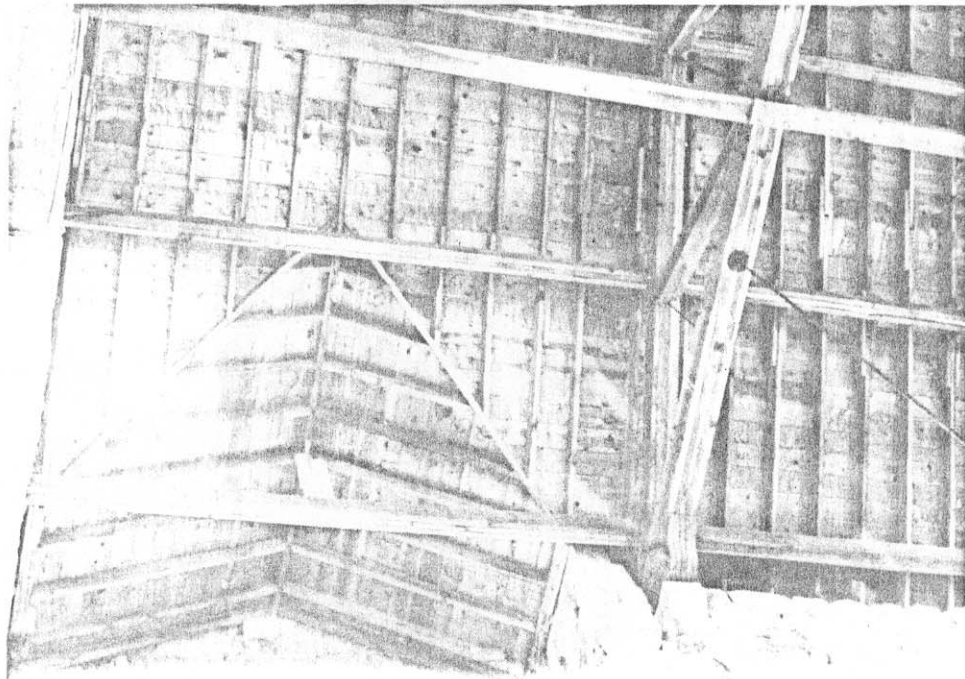
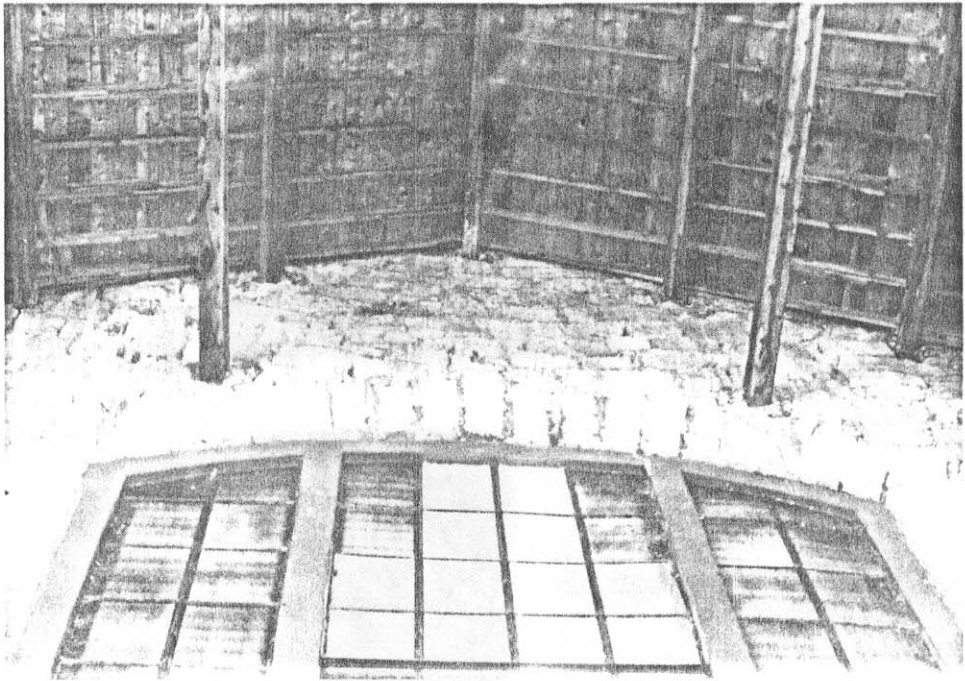
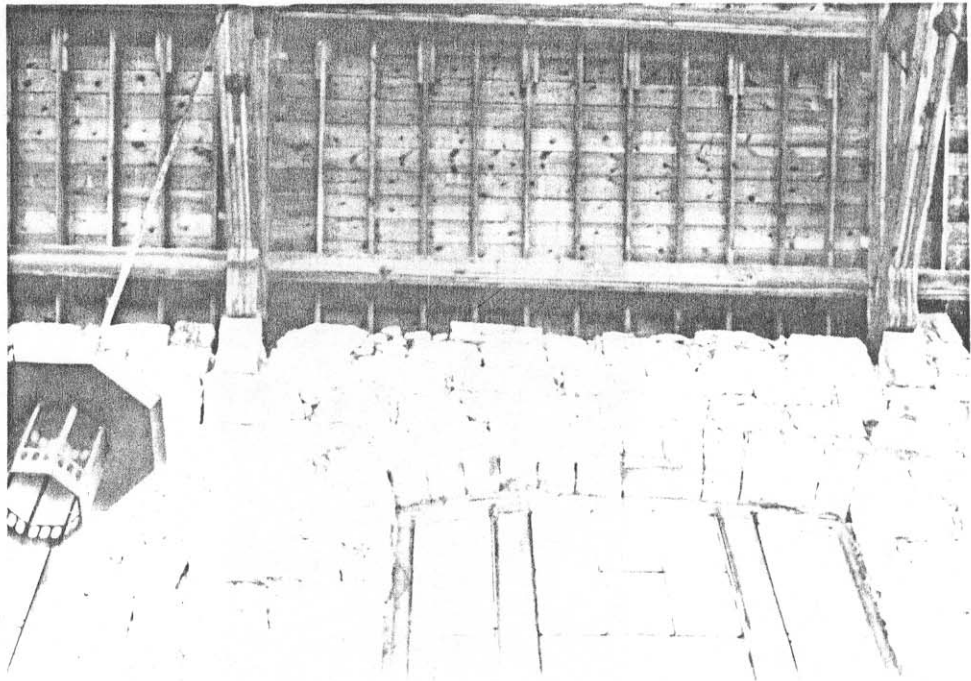
Photo Set 5 - Roof Truss System

The interior roof support system, as observed from the floor of the church, appears to be in good condition. The system consists of timber trusses which span the width of the church and are supported by stone buttresses. Timber beams, which run parallel to the church side walls, connect the trusses. The following photo illustrates the interior roof support system.

The foundation of the building appears to be in good condition with only minimal settling of the foundation. The roof truss system also appears in good condition despite its age. This summarizes the findings of our inspection team. The purpose of our inspection was to provide our opinion of the church's condition. Additional study by a professional engineer or licensed contractor is needed to determine exactly what renovations are necessary.
